MOORE INSPECTIONS LLC

SEWER INSPECTION

1234 Main St.

12/09/2021 9:00AM

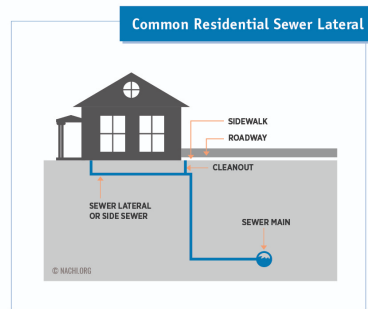
Drain System: Materials from access

Cast Iron, Clay
