MOORE INSPECTIONS LLC

SEWER INSPECTION

1234 Main St.

12/09/2021 9:00AM

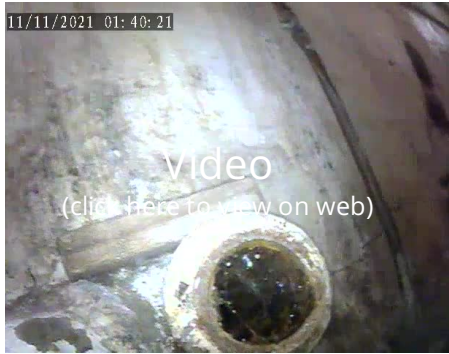
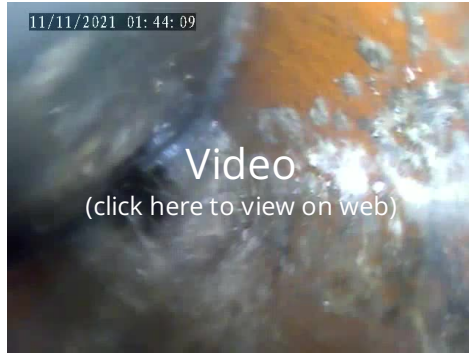
Video

The sewer video shows the lateral to main to be in poor condition. The material appears to be clay pipe with joints every 4 feet. At many of the joints there are root intrusions that block the pipe almost fully. Additionally there is one significant belly in the pipe, this could be a break in the pipe. I was not able to get the camera to the lateral junction to the main. I would recommend for immediate use you have the line jetted or foamed to remove the roots in order to clear the line. For long term use it is recommended to replace the line.

Please click link below or copy and paste to search bar to watch the sewer line video inspection:
